ELLIS ISLAND, CONTAGIOUS DISEASE HOSPITAL MORTUARY
(Ellis Island, Animal House)
(U.S. Immigration Station)
Statue of Liberty National Monument
New York Harbor
New York
New York County
New York

HABS NY-6086-N
NY-6086-N

ELLIS ISLAND, CONTAGIOUS DISEASE HOSPITAL MORTUARY (Ellis Island, Contagious Disease Hospital Animal House)

HABS No. NY-6086-N

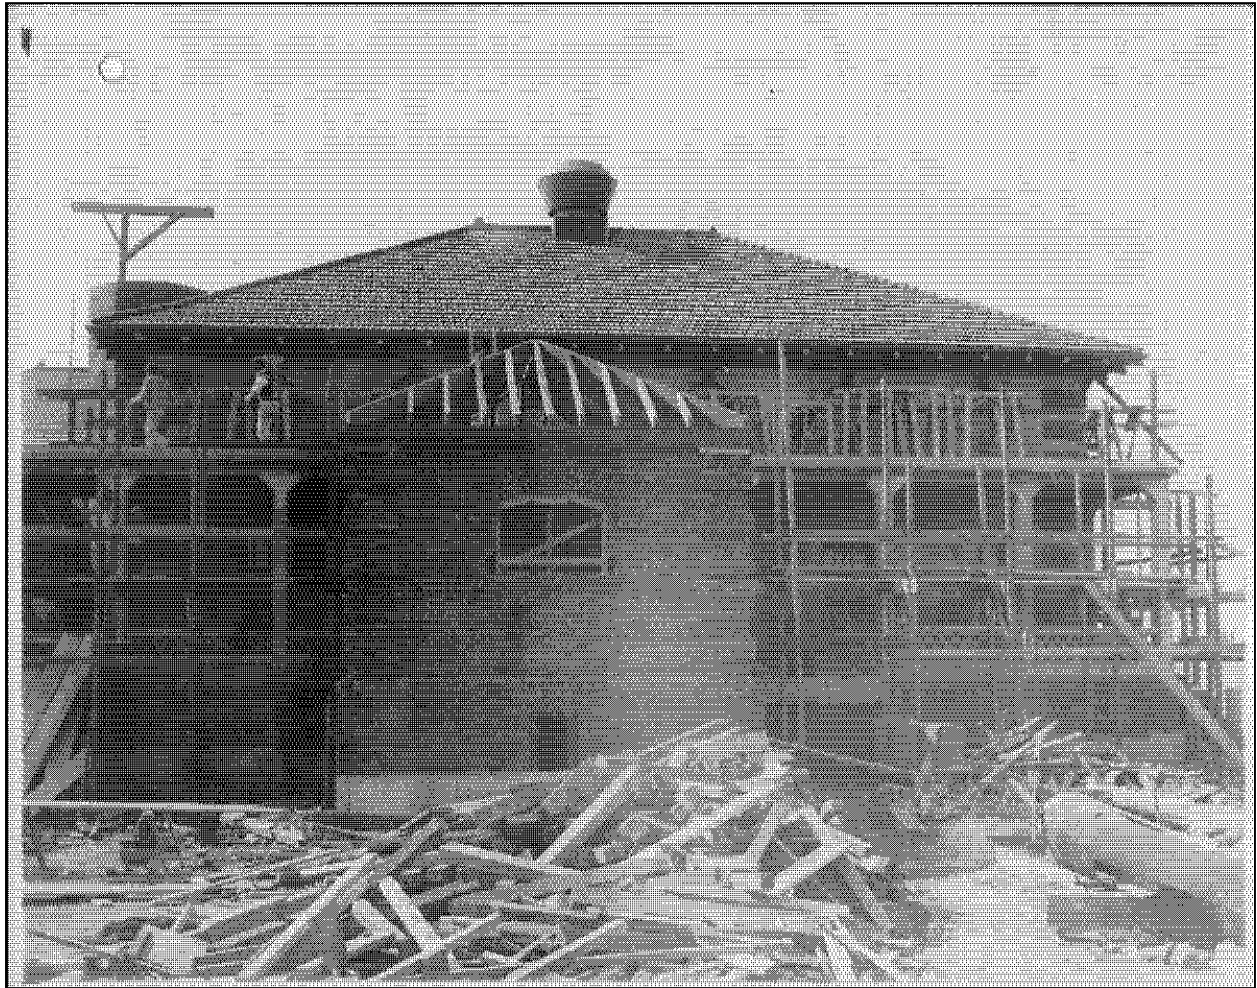
Figure 4: Mortuary and Powerhouse looking Southwest (under construction), (14 October 1907)
(Photo No. 121-BCP-38A-21H)

included in this contract was construction for Wards C, D, L, the staff house, the two-story corridor from the power house to Ward E, Ward F and Ward B to the south of ward H, and the pipe tunnel and trench that ran under the corridor.²⁹ The contract included a budget and scope for only about half of the work program, and the government agreed to provide North-Eastern Construction Co. authorization for the remaining work within 12 months at the bid prices. Photographs dated late 1907 and early 1908 show the Mortuary under construction. (Figures 4-6)

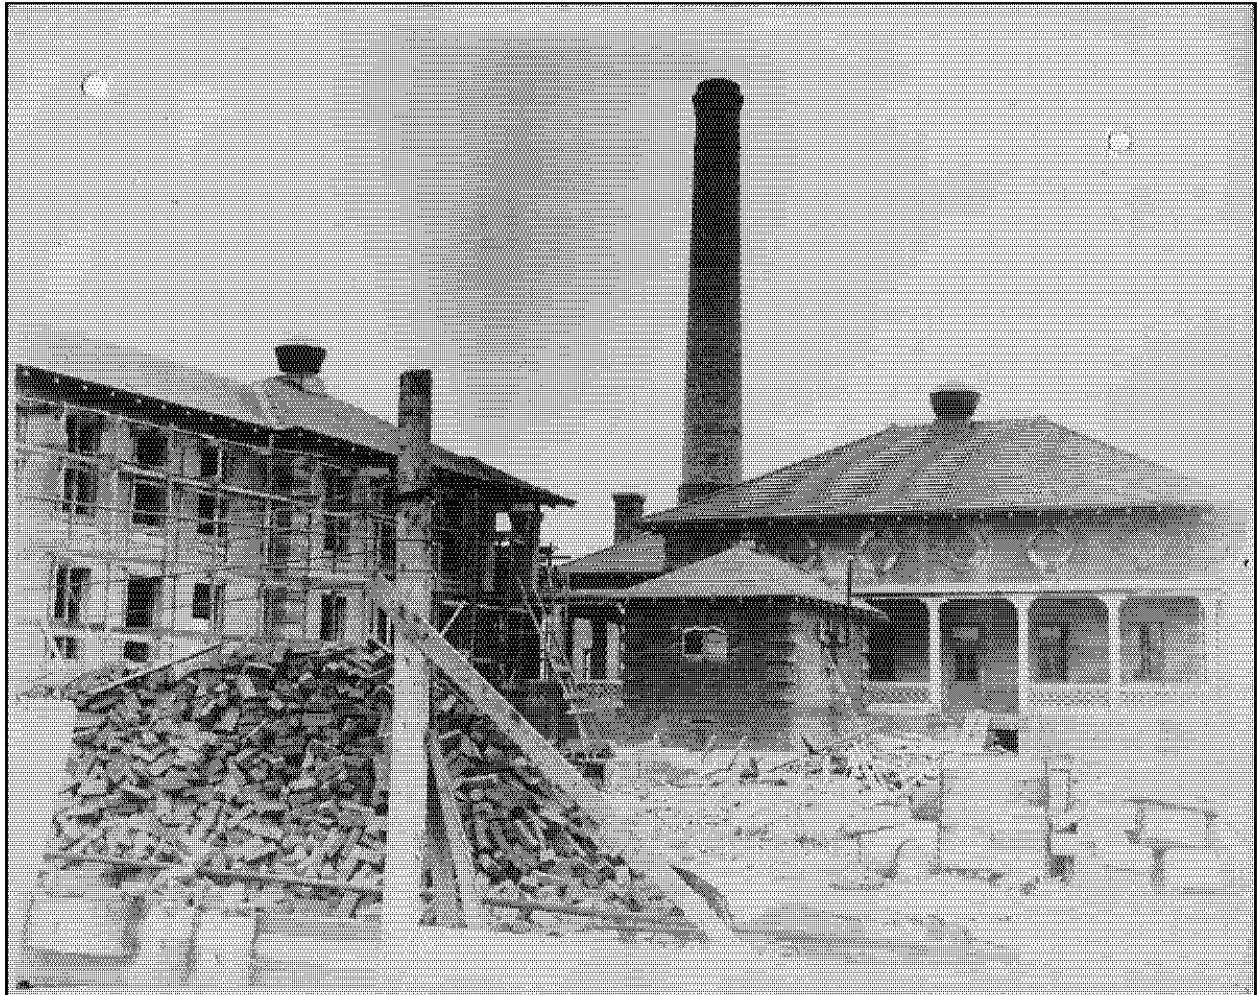
Figure 5: Mortuary, Measles Ward G, and Powerhouse, Looking South, (16 December 1907),
(Photo No. 121-BCP-38A1-22H)

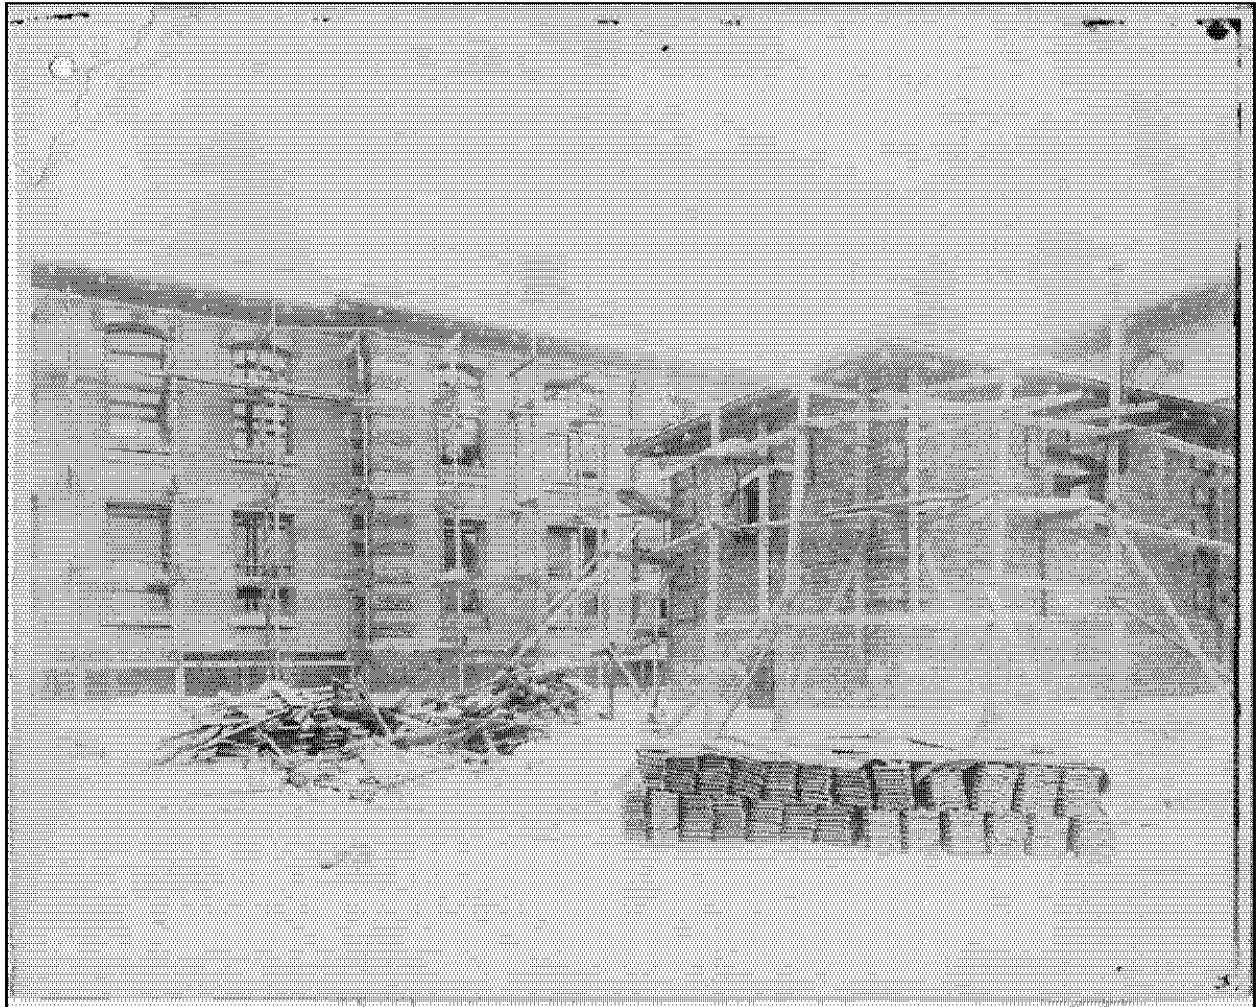
Figure 6: Measles Ward G and Mortuary, Looking Southeast, (11 February 1908),
(Photo No. 121-BCP-38A1-24F)
